WATER DAMAGE RESTORATION: GRADY MEMORIAL HOSPITAL

BY GREG VALE

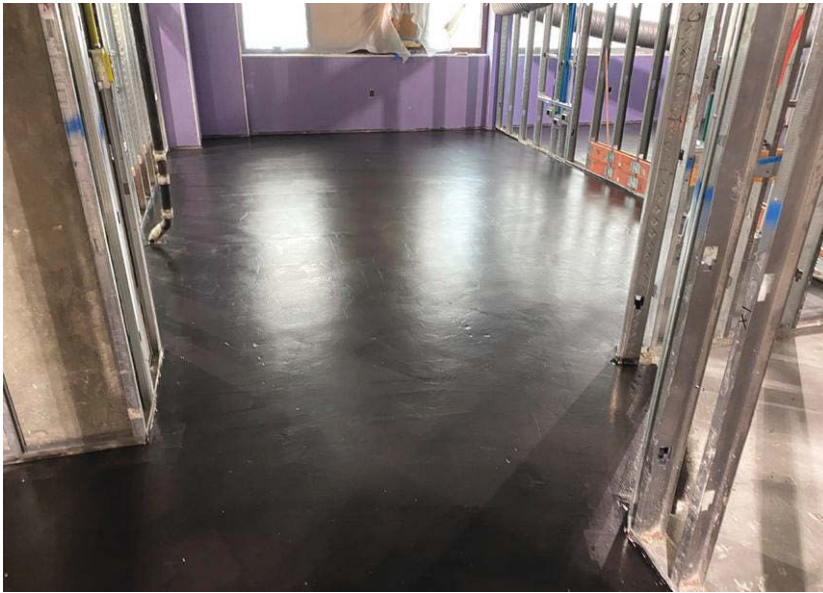
Left: The original flooring at Grady Memorial Hospital dates back to 1892 and renovations and additions over time created a variety of issues that needed to be addressed. As a first step, Ardex K 13 self-leveling underlayment was used to level and smooth the substrate to create a surface that would handle any type of resilient flooring.

have been renovations and additions, which created a variety of issues with the concrete substrate. Also, the residue from all of the old glues, self-leveling and patching compounds had to be removed in order to create a surface profile that would handle any type of resilient flooring.

It was determined that Ardex K 13 self-leveling underlayment would be used to level and smooth the substrate. “The product is excellent when remediating concrete containing old patch and non-water-soluble adhesive residue,” according to Tomasik. “It's walkable in two to three hours and most floor coverings can be installed on the substrate 16 hours after it is applied.”

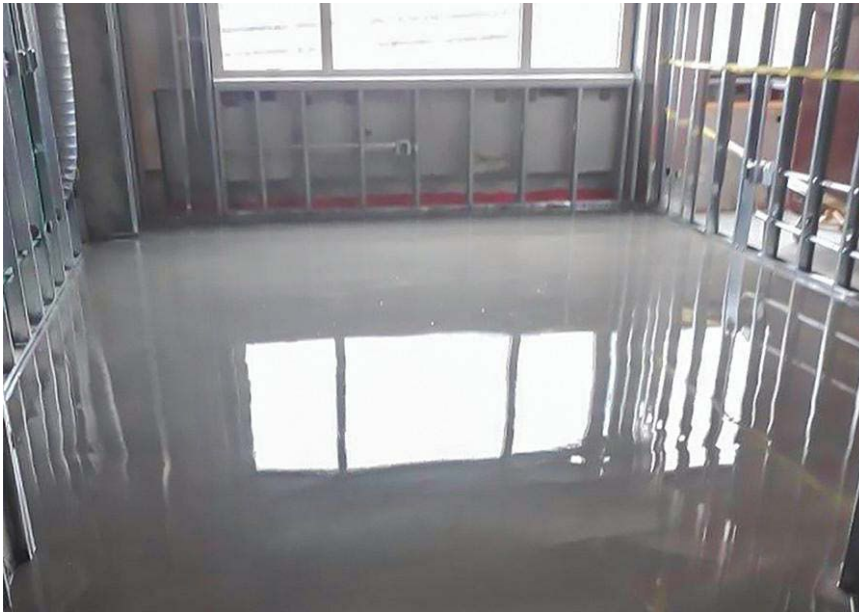
Left: Extremely high moisture levels in the hospital's flooring substrate were a serious problem. Because the renovation project was on a fast track to completion, the Ardex MC Rapid moisture control system, which dries in as little as four hours, was used to reduce moisture levels.

The Ardex MC Rapid moisture control system was used to address the very high moisture levels in the hospital's substrates. The one-coat system is formulated to suppress excessive moisture vapor emissions levels up to 100 percent. It is also fast setting, so work on the substrate can proceed in as little as four hours.
