# floor trends

# WATER DAMAGE RESTORATION: GRADY MEMORIAL HOSPITAL

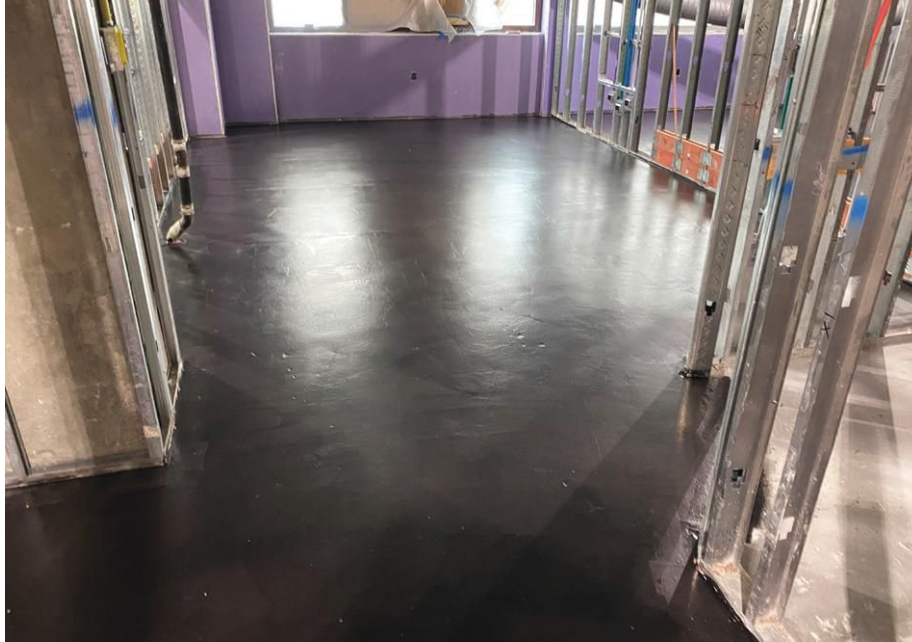
The original flooring at Grady Memorial Hospital dates back to 1892 and renovations and additions over time created a variety of issues that needed to be addressed. As a first step, Ardex K 13 self-leveling underlayment was used to level and smooth the substrate to create a surface that would handle any type of resilient flooring.

It was determined that Ardex K 13 self-leveling underlayment would be used to level and smooth the substrate. “The product is excellent when remediating concrete containing old patch and non-water-soluble adhesive residue,” according to Tomasik. “It's walkable in two to three hours and most floor coverings can be installed on the substrate 16 hours after it is applied.”

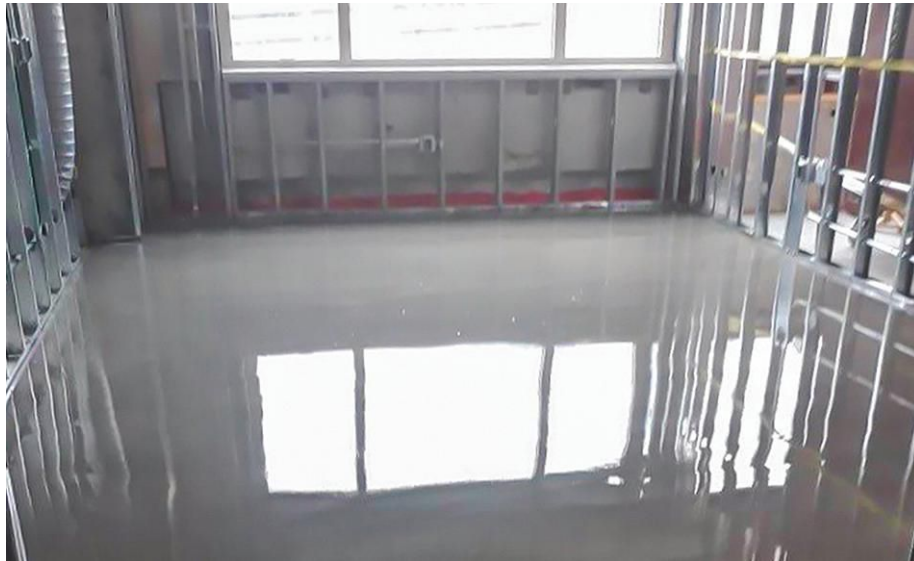
**Extremely high moisture levels in the hospital's flooring substrate were a serious problem. Because the renovation project was on a fast track to completion, the Ardex MC Rapid moisture control system, which dries in as little as four hours, was used to reduce moisture levels.**

The Ardex MC Rapid moisture control system was used to address the very high moisture levels in the hospital's substrates. The one-coat system is formulated to suppress excessive moisture vapor emissions levels up to 100 percent. It is also fast setting, so work on the substrate can proceed in as little as four hours.
